SI98.00-P-0015A	Service Information: Painting bumpers with short range radar	18.8.15
-----------------	--	---------

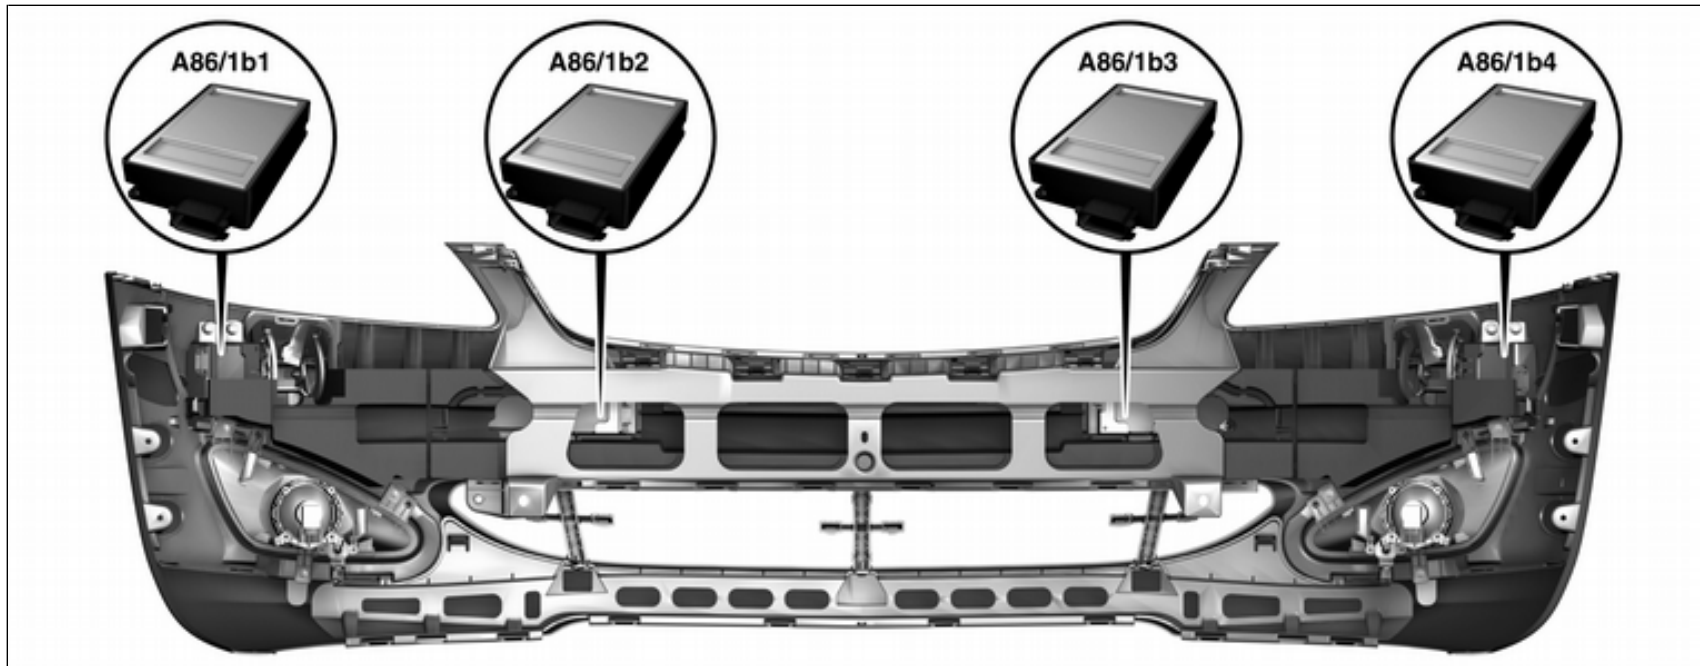
P30.30-2075-08

Location of radar sensors in front bumper, shown on model 221

i When performing filling and painting work on the bumpers, it is important to make sure that the maximum coat thickness is not exceeded at the short range radar sensors. This can lead to malfunctions as the sensors detect the excessive coat thickness as an obstacle. The limit value for the coat thickness at the sensors is two coats of paint.

i If the short range radar does not function correctly after painting, either the paint must be removed or the bumper must be replaced.

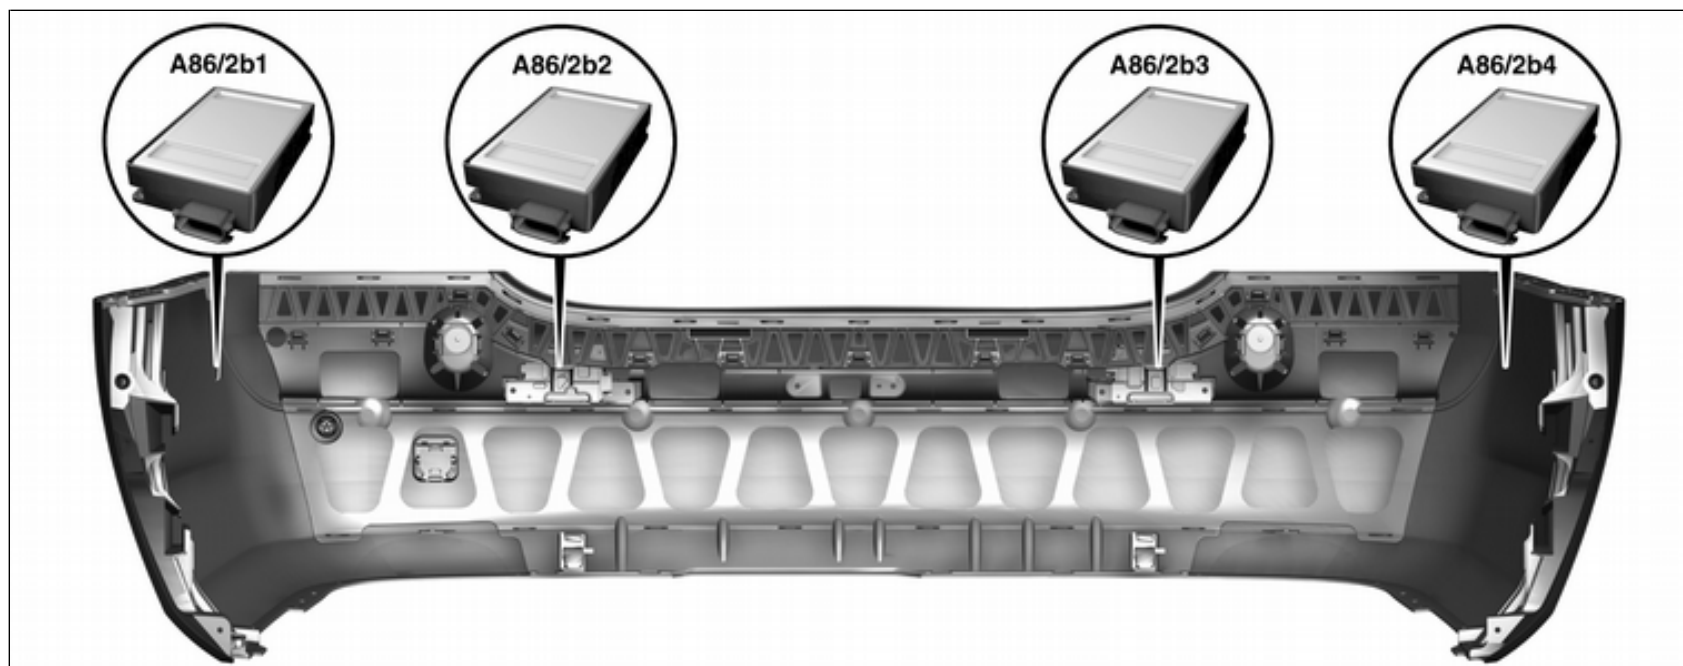
P30.30-2076-08

Location of radar sensors in rear bumper, shown on model 221
