**Models Affected**

- 2012 Honda Civic Sedan**
- 2012 Honda Civic Sedan Si**
- 2011 Honda CR-V**

**SRS Replacement Parts**

**This Parts Information Update is in reference to a ServiceNews Article dated June 2012 entitled, "Wrong SRS Replacement Parts Can Cause SRS DTCs 41-xx thru 46-xx"**

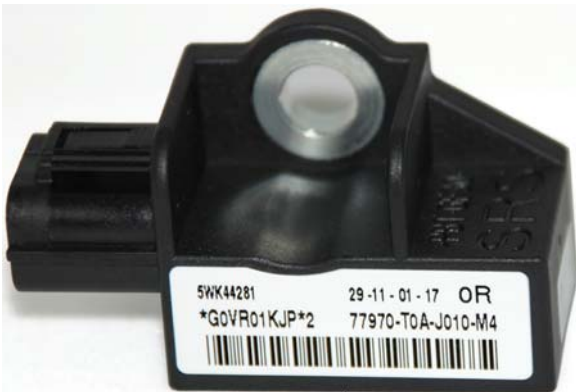
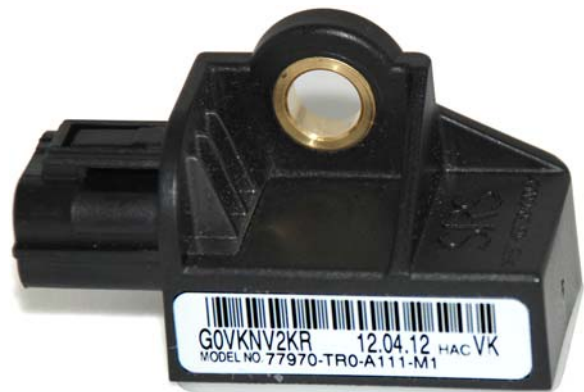
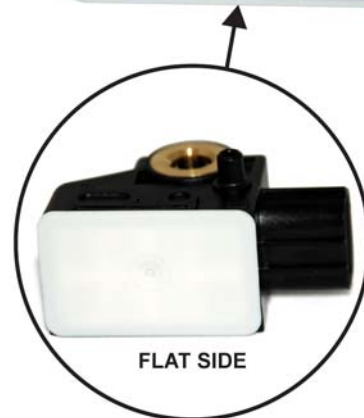
## Front and Side Impact Sensors

- The flat side of a Continental impact sensor is **black**.

- The flat side of a TRW impact sensor is **white**.
- There are no logos on either sensor
- TRW impact sensors have three angular braces next to the mounting bolt hole.
- The replacement part number for either sensor is the first 11 characters of the 14-character model number on the barcode label

After a deployment, the SRS system must be restored with replacement parts from the same supplier that was originally used in production. If those parts are mixed and matched on the same vehicle, the SRS light will remain on.
