RCI-52-22-007-4: Model Year 2022-2024 Vehicles R1T Material Matrix and Repair Guide

Rivian Automotive, LLC Service Document

Document Type	Collision Repair Information Document
Date	October 31, 2024
Affected Region(s)	USA
Affected Model(s)	R1T
Model Year(s)	2022-2024 Vehicles
Vehicle System	52 - Body

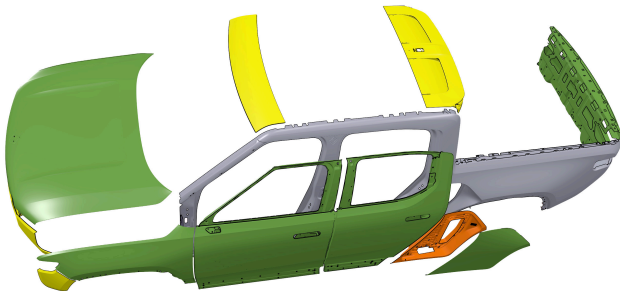
Closures & Exterior Trim

Color Key	Material Type
■	Conventional Steel
■	Aluminum Sheet
■	Magnesium
■	Plastic
